## Problems - Causes and Cures

Association of Wall and Ceiling Industries

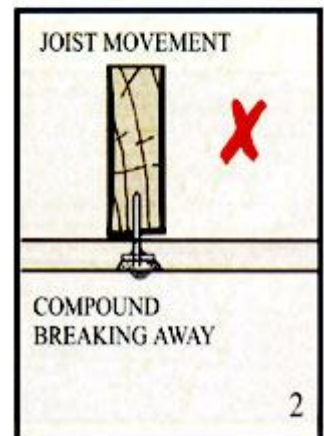
Whenever the back of the plasterboard is not held tight and secure against the face of the framing member by the head of the fastener, a potential fastener pop exists. Figure 1 shows plasterboard held tight and secure against the framing member. Figure 2 shows a fastener pop as a result of moisture movement in timber. Figure 3 shows the board not held tight and secure against the framing.

Moisture movement in timber, is the likely cause of fastener pops occurring after decoration.

An appropriate fastener should be fixed about 50 mm from the popped fastener applying sufficient pressure against the plasterboard to assure firm contact with the framing. Remove loose compound, apply new compound as required.
